## Evaluation of Concrete Pavers Affected by Manavgat Wildfires

# Evaluation of concrete pavers affected by Manavgat wildfires

Climate change, concrete, concrete pavers, compressive strength, wildfire

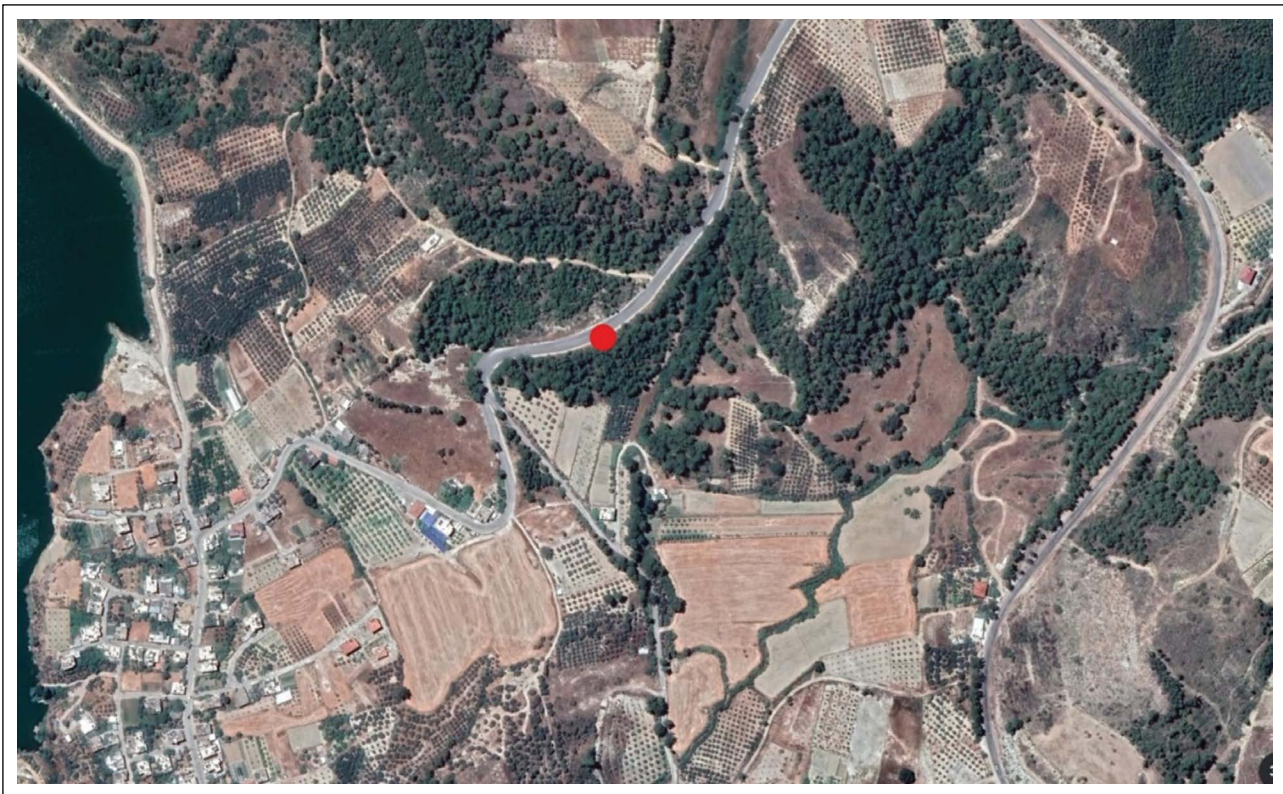
**Figure 1.** Manavgat-Oymapınar Neighborhood.

In order to obtain the materials in this research, the Manavgat fire area was investigated. The area shown in Figure 1 is the Oymapınar neighborhood. It is clearly seen that this region, where forest and habitats are very close to each other, is WUI.

The field marked red in Figure 1 is the area with the most affected pavement from the fire. It was decided to take the samples from this area. When the paving stones were examined, it was seen that there were completely burned, half-burned and unburned concrete paving stones in the same area. It is planned to take three samples from all three combustion conditions to compare them with each other in terms of the mean value of compressive strength. The pavement affected by the fire is shown in Figure 2.

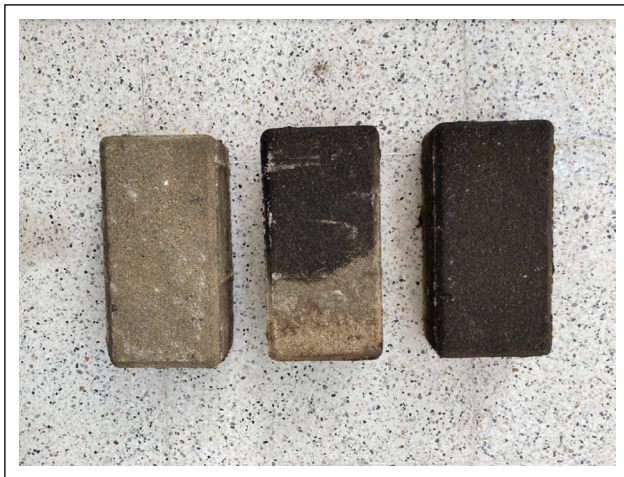
**Figure 3.** Concrete paving stones in different conditions.

A sample of the completely burned, half-burned and unburned concrete paving stones taken from the Manavgat wildfire area are shown in the Figure 3.

All experiments were successfully completed, and compressive strengths were obtained in accordance with the standard of BS6717 [14, 15]. The compressive strengths measured as a result of the tests are shown in the Table 2. According to the results obtained, the mean value of compressive strengths of unburned, half-burned, and completely burned stones were 36.04 MPa, 49.51 MPa, and 50.83 MPa, respectively.

It is seen that the compressive strength increases as the amount of combustion increases. Normally, the strength of concrete is expected to decrease when exposed to very high temperatures. The reason for the increase in the strength of concrete paving stones may be that the fire went out before it reached a very high temperature on the pavements in the region. A well-known basic fact in thermodynamics, gases have higher temperatures rise up depending on their low density. Increasing in the strengths of the concrete pavers in the burned regions like heat-treated concrete can be explained using this fundamental thermodynamic law. It is also an indication that the fire does not burn the entire pavement and does not spread to the driveway. These results are also consistent with the study [12] in the literature that concretes treated at 250 °C have higher strength than concretes at room temperature.

The results obtained prevent the replacement of paving stones in the region due to strength. However, this result also needs to be evaluated from an architectural point of view. It is clear that the half-burned and completely burned concrete pavers are dirty and have colour mismatch. Therefore, replacement or staining of the stones may be considered.

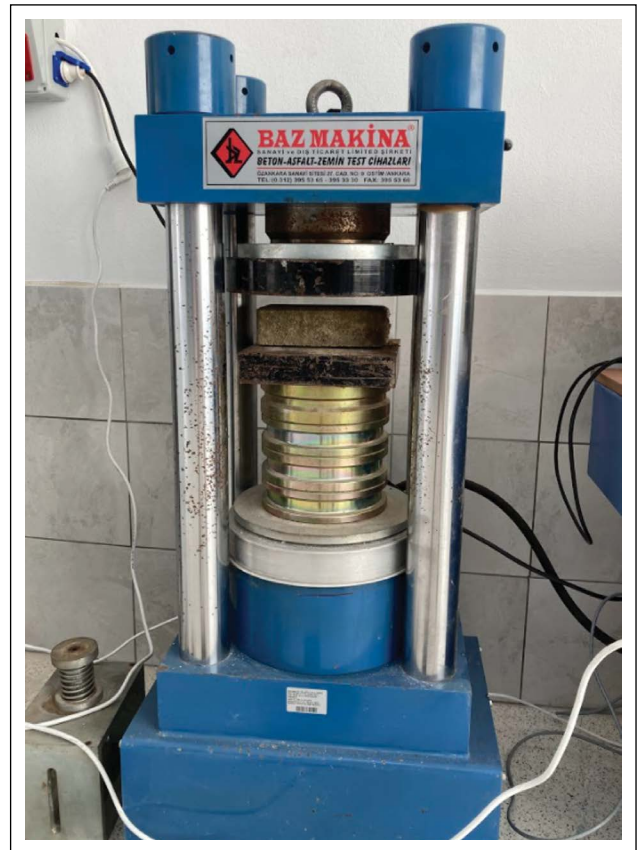
**Figure 4.** Compression testing machine.

The paving stones were tested in the pressure machine in the Civil Engineering Laboratory of Alanya Alaaddin Keykubat University. The experimental setup is shown in the Figure 4.
