## Sustainability Evaluation of Highway Sign Support by Field Testing and Finite Element Analysis

# Sustainability evaluation of highway sign support by field testing and finite element analysis

Highway sign supports, finite element analysis, field test

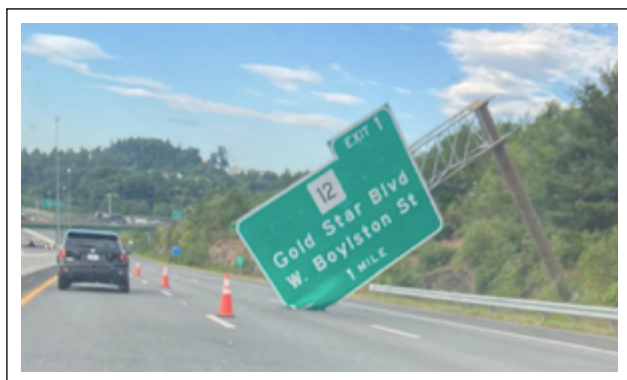
**Figure 1.** Collapsed sign support.

An event occurred on I-190 SB in Worcester, Massachusetts, that underscores the importance of this project. On August 9<sup>th</sup>, 2022, a cantilevered sign support collapsed on the roadway, obstructing the low-speed and middle lanes (Fig. 1). Thankfully, no motorists were injured, and the Massachusetts Department of Transportation (MassDOT) had the road cleared the following day [1]. Still, such an incident illustrates the potential risk associated with these structures and what can happen if they are not regularly maintained.

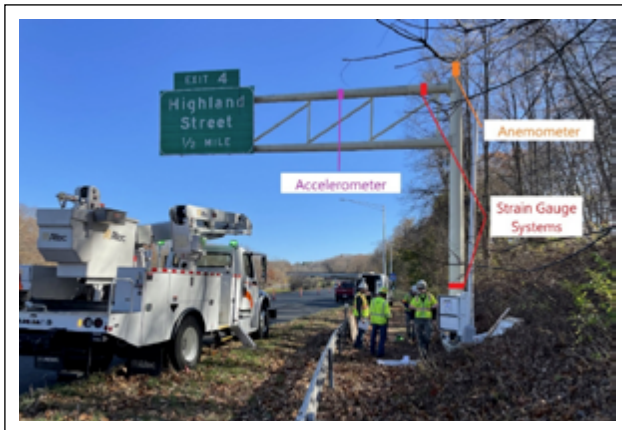
Figure 7. CTDOT Asset no. 21740.

In 2022, CTDOT sign support asset 21740, located over I-384 in Manchester, Connecticut, was chosen for the field test portion of the project (Fig. 7). The sign support type is a Truss Arm Cantilever made of steel. This task involved the use of a data acquisition system and instrumentation that included (1) Anemometers to obtain wind velocity and direction, (2) Accelerometers to obtain the acceleration response of the structure, and (3) Strain Gauges to measure the strain response of the structure. The accelerometer type has a 5g sensitivity option for dynamic structural testing in tough field conditions. Four strain gauges were installed at the base of the pole of the overhead sign support structure, four strain gauges at the top arm of the lattice structure holding the arm, and one accelerometer and one anemometer at the top arm. Figure 8 shows the dimensions schematic

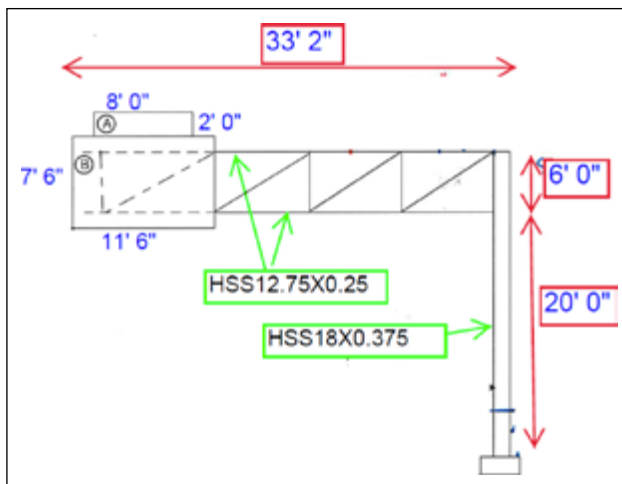
Figure 8. Dimensions schematic of sign support 21740.

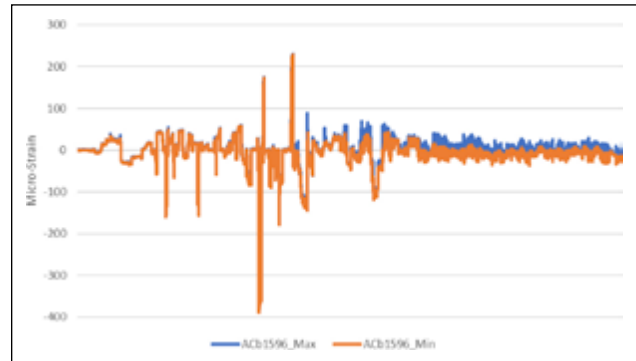
Figure 9. Graph of the top strain gauges data for channel 1 - Up and down positions.

The following graphs, Figure 9, Figure 10, Figure 11, and Figure 12, provide the strain gauge data over time. Figure 13 presents the wind speed data over the same time frame.

The experimental results show that the top horizontal arm experienced higher strains than the bottom of the vertical pole. Further, the maximum strain was experienced only once and reached a value of 380 micro-strain. Otherwise, the strain range was between 50 micro-strain and 130 micro-strain.

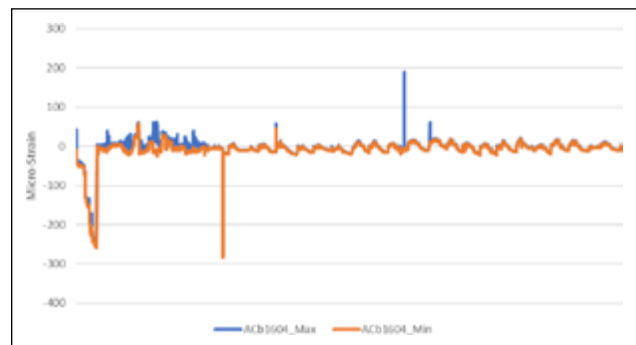
Figure 10. Graph of the top strain gauges data for channel 2 - East and west positions.

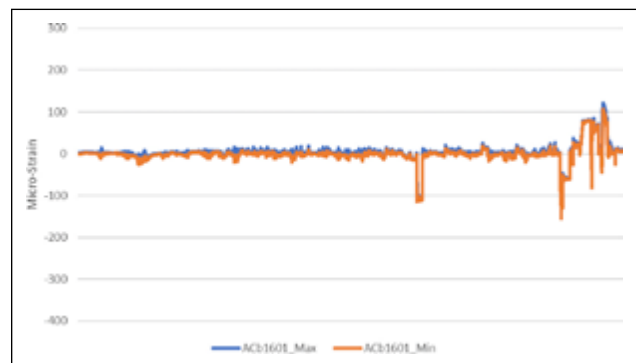
Figure 11. Graph of the bottom strain gauges data for channel 3 - North and south positions.

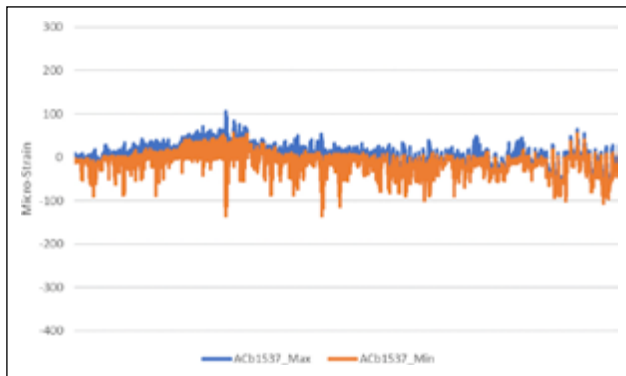
**Figure 12.** Graph of the bottom strain gauges data for channel 4 – East and west positions.

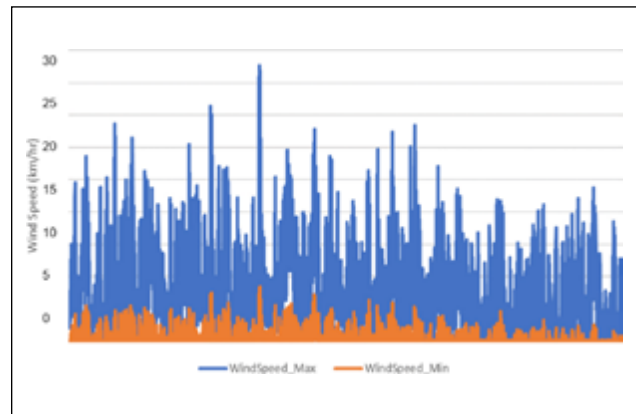
**Figure 13.** Graph of wind speed sensor.

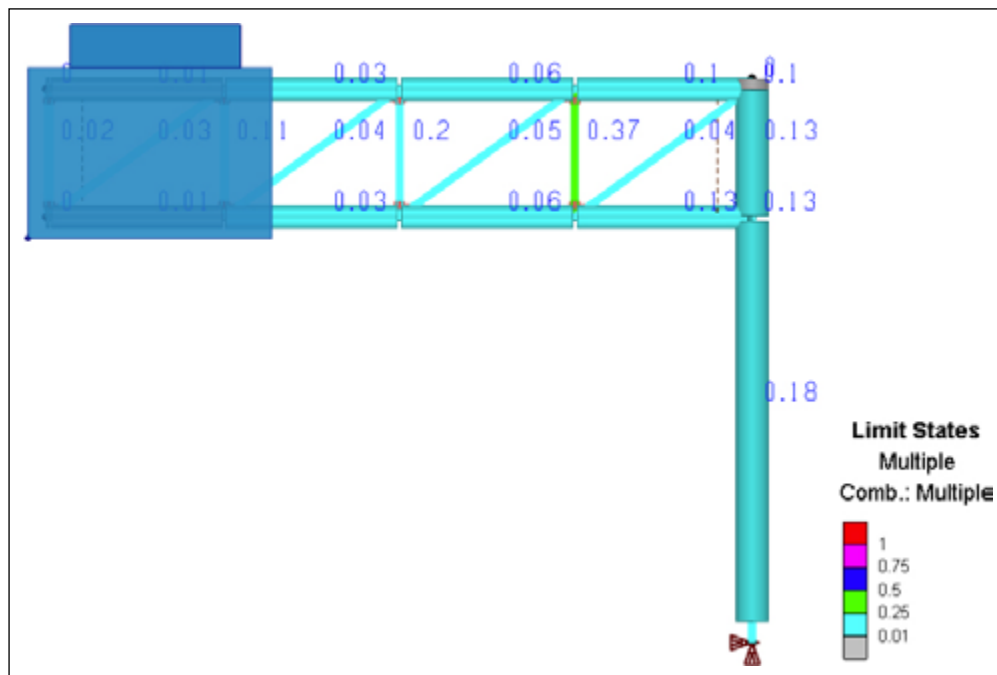
**Figure 14.** FE Model analysis due to wind load of 28 km/hr (45 mph) to simulate experimental data.

developed, and the wind load applied was the average value of 28 km/hr (45 mph) obtained from the wind speed data. The limit state values (Fig. 14) show that the vertical pole has a value of 0.18 (18%) of the actual pole capacity, within a 10% difference compared to the experimental data. Similarly, the top horizontal cantilever arm has a limit state value of 0.10 (10%) of the capacity, which is, on average, about 8% less than the experimental data.

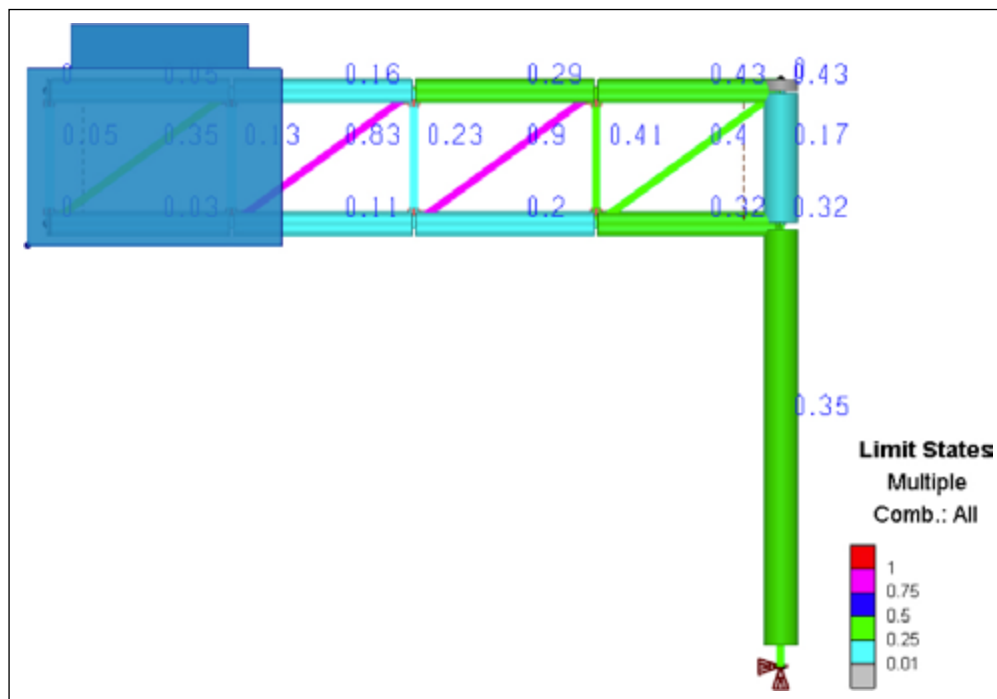
**Figure 15.** Limit states for all load combinations where results exclude fatigue.

These results show that the model is accurate and can be used to predict the behavior of the sign support at complete design load capacity. The second model was then developed with the whole design load applied by the AASHTO LRFD-LTS code, which accounts for the wind load at the region where the sign support is, namely Hartford, Connecticut. The analysis results depend on including or excluding fatigue stress in the limit state load combinations. Fatigue has a significant impact on the results, as seen in Figure 15 and Figure 16. Fatigue stress is so substantial that some sections exceed their limit state.

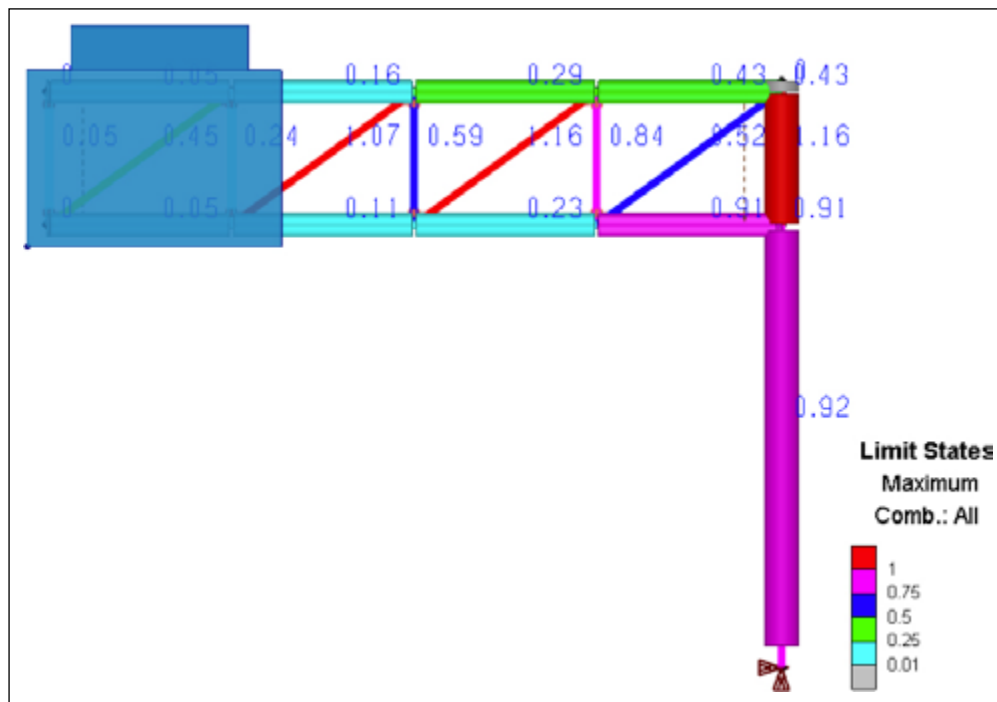
**Figure 16.** Limit states for all load combinations where results include fatigue.
