# Informative integration of modern spolia in public landscapes

Deniz ÜÇER ERDURAN<sup>\*,1,2</sup>

Demolition, end-of-life, repurposing, spolia

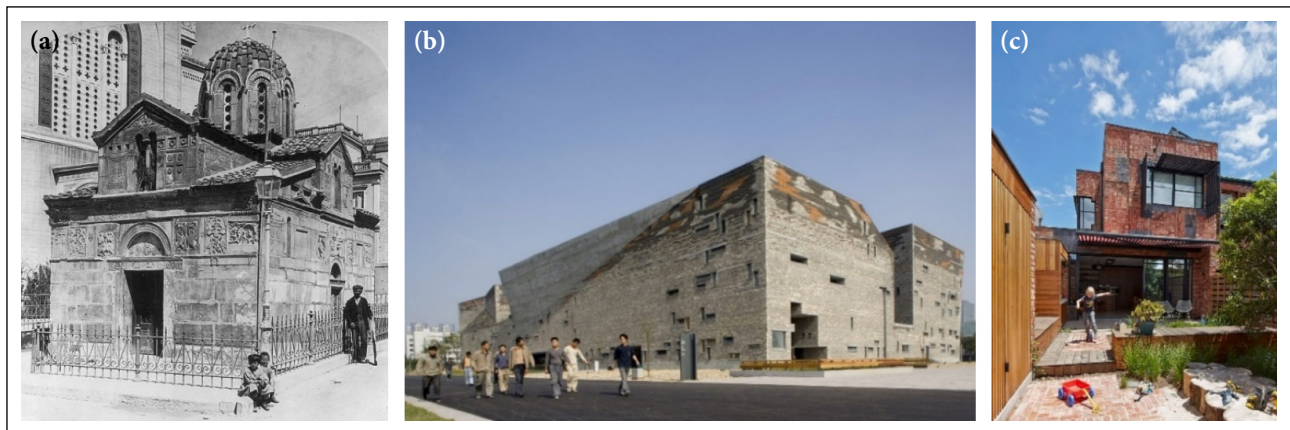
**Figure 1.** (a) Reliefs, such as spolia, were held within the Byzantine church of the Small Metropolis in Athens, Greece [19]. (b) Reused materials within the History Museum in Ningbo, China [20]. (c) Salvaged walls within the Cubo House in Melbourne, Australia [21].

In other contexts, spolia has served as a means of transferring vernacular materials and craftsmanship that evolved. In this respect, it represents a tradition born from experimental trials influenced by the dynamics of specific territories [4]. A contemporary example is the History Museum in Ningbo, China, where materials and techniques from abandoned and ruined villages were rearranged into a public-scale building. The project employed a local version of masonry construction, the Wapan technique, which combines various unit-based materials into a compelling composition [12]. The result is a rich textural aesthetic and strong reminders of the original context, expressed through material and technique (Fig. 1b).

Even when materials are mass-produced, their integration into a design reflects the intentions of their creators and embodies values worth transferring [4]. For example, Cubo House in Melbourne, Australia, documents the narrative of a characteristic house through its integration into a new structure using salvaged materials. A carefully managed deconstruction process was implemented, allowing the materials to be reintegrated into the new building. The architects documented the history of the original structure by salvaging its components, connecting this effort to the concept they referred to as “embodied memory” (Fig. 1c) [17].

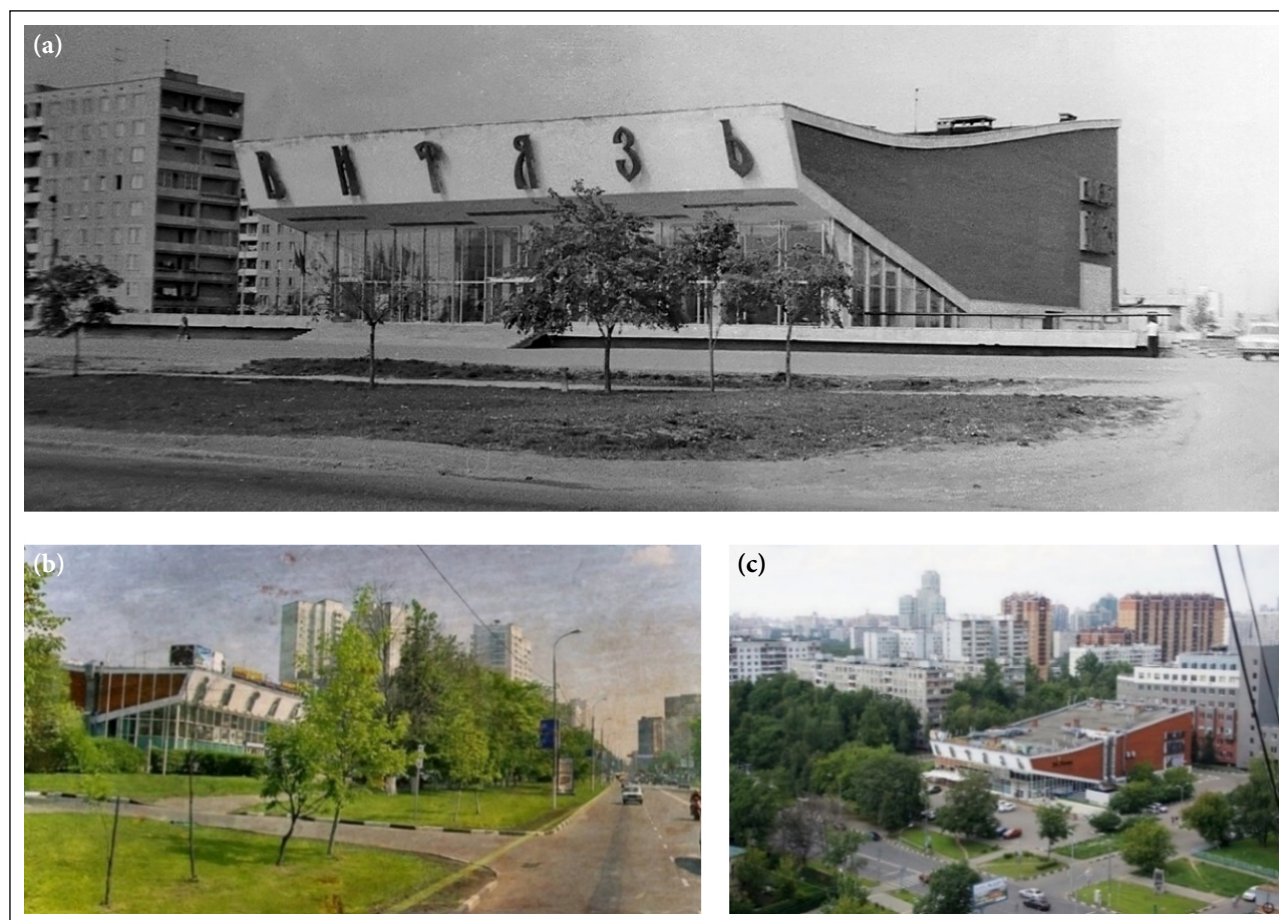
**Figure 2.** (a) The Vityaz Movie Theatre shortly after its completion in 1975 [34]. (b) The Vityaz Movie Theatre during the 1990s [35]. (c) The Vityaz Movie Theatre in the 2000s [36].

The Vityaz Movie Theatre (Kino Vityaz), constructed in 1970 in the Belyayevo district of southern Moscow, played a pivotal role in the area's social and cultural landscape until its demolition in 2019 (Fig. 2a). Belyayevo, originally a suburban town, was integrated into Moscow's urban core

Until the 1990s, the district's architectural style evolved with increased typological diversity and taller buildings. However, the design language remained consistent, characterized by straightforward forms and facades (Fig. 2b). After the dissolution of the Soviet Union in 1991, the government

Since then, the area has adopted an eclectic urban design, blending architectural styles from multiple decades. Within this context, the Vityaz Movie Theatre significantly represented 1970s architecture (Fig. 2c).

The building had a footprint of around 2800 m<sup>2</sup> and reached a height of 18.5 meters at its tallest point. It was surrounded by a park, contributing to its prominence as a social and cultural destination in the district. Architecturally, the facades featured concrete components framing brick walls, creating a modernist appearance typical of Soviet-era public buildings. The entrance was designed with a glass foyer beneath the auditorium, intended to welcome the audience in a visually open and inviting manner (Fig. 2a).

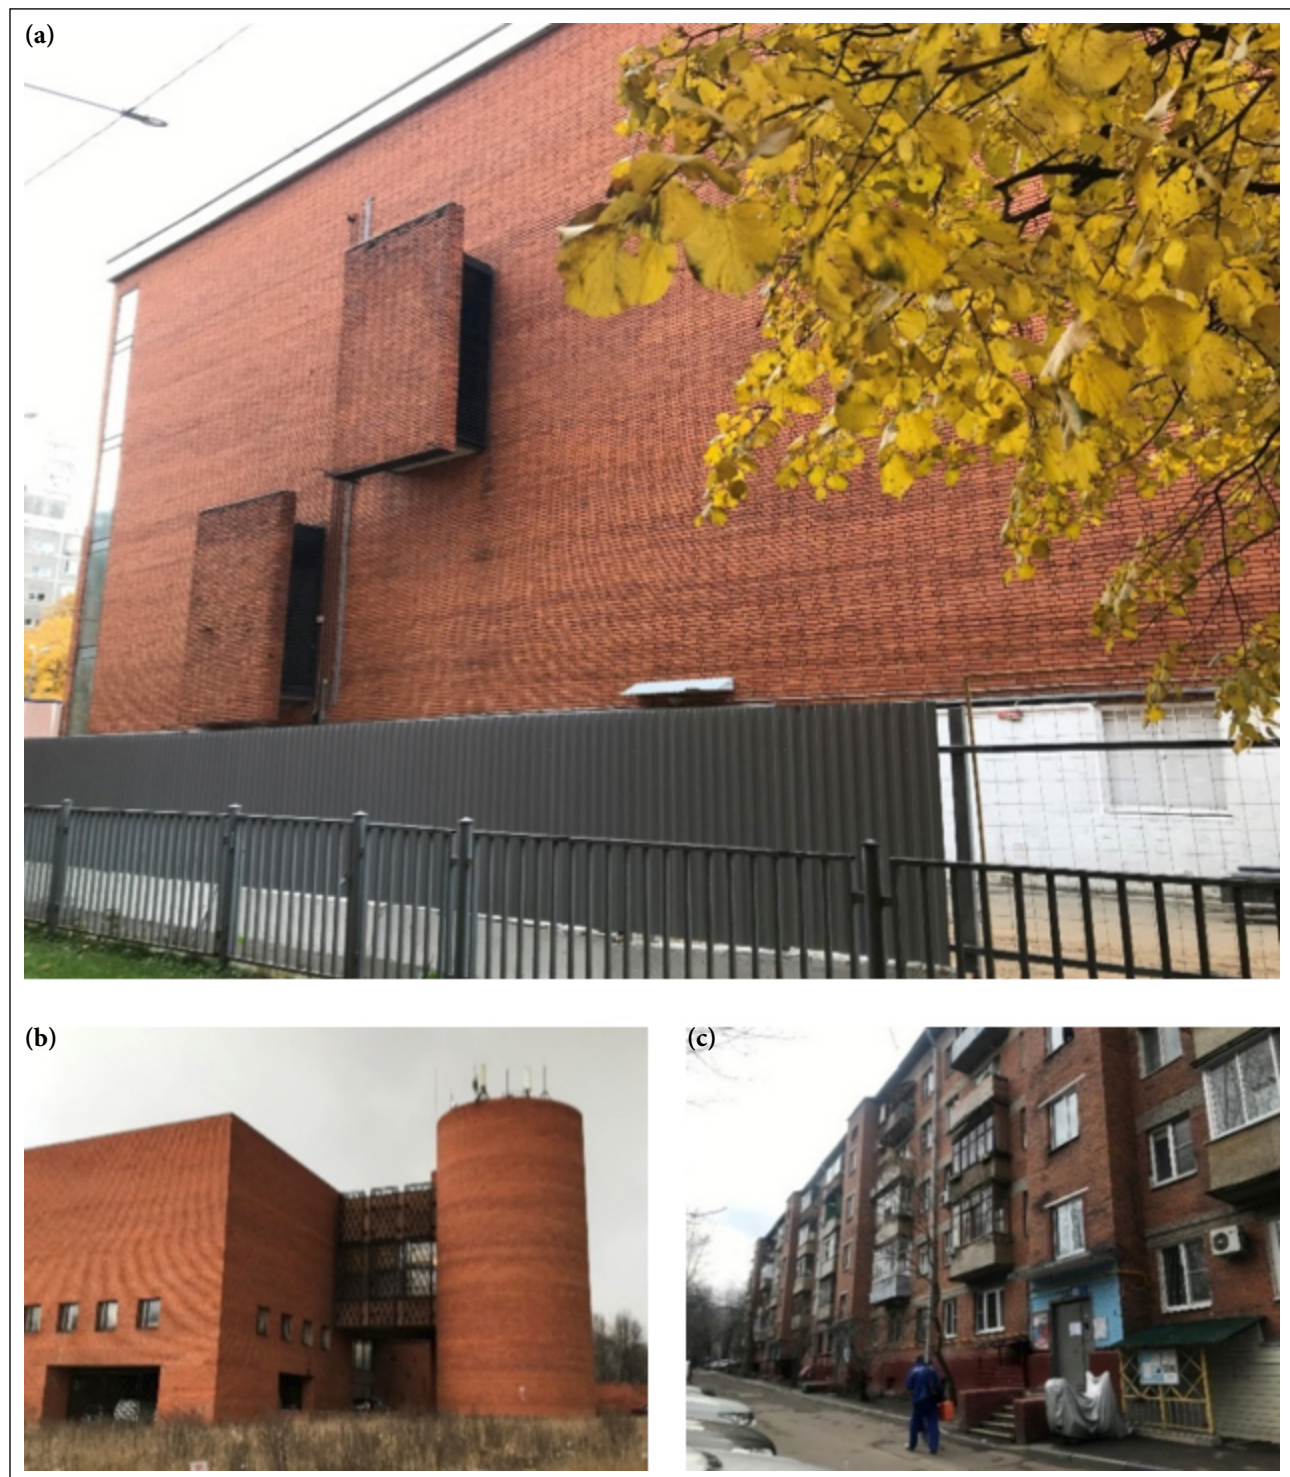
**Figure 4.** (a) The rear façade of the Vityaz Movie Theatre was captured during demolition. (b) Typical fenestration openings in brick façades across the city: Orlov Paleontological Museum (1965–1989), Moscow. (c) Five-story mass housing was constructed in Moscow in the 1960s and 1970s.

The facades of the Vityaz Movie Theatre featured expertly integrated brickwork, with the rear façade showcasing a particularly innovative design. Two projecting wall sections were placed on a large, flat surface, contributing to the building's dynamic architectural expression (Fig. 4a). While these projections maintained the appearance of a seamless brick wall, they also incorporated apertures that allowed natural light and fresh air to flow in from the sides. This design preserved privacy and met the practical needs of service areas, offices, and technical rooms.

During demolition, it was revealed that steel members were used to secure the projecting wall sections mechanically. This hidden integration of steel within the brick structure highlighted the technical sophistication of the building's original design. Using steel would have allowed for potential dismantling during deconstruction, which could have supported the adaptability and repurposing of materials.

The significance of this design solution lies in its departure from the conventional approach to fenestration openings. Wall openings, typically formed by punched holes in brick walls, were a standard feature in various building types, from modest residential buildings to large public spaces such as museums (Fig. 4b, c). However, the approach used for the Vityaz Movie Theatre clearly distinguished itself from these conventional practices.

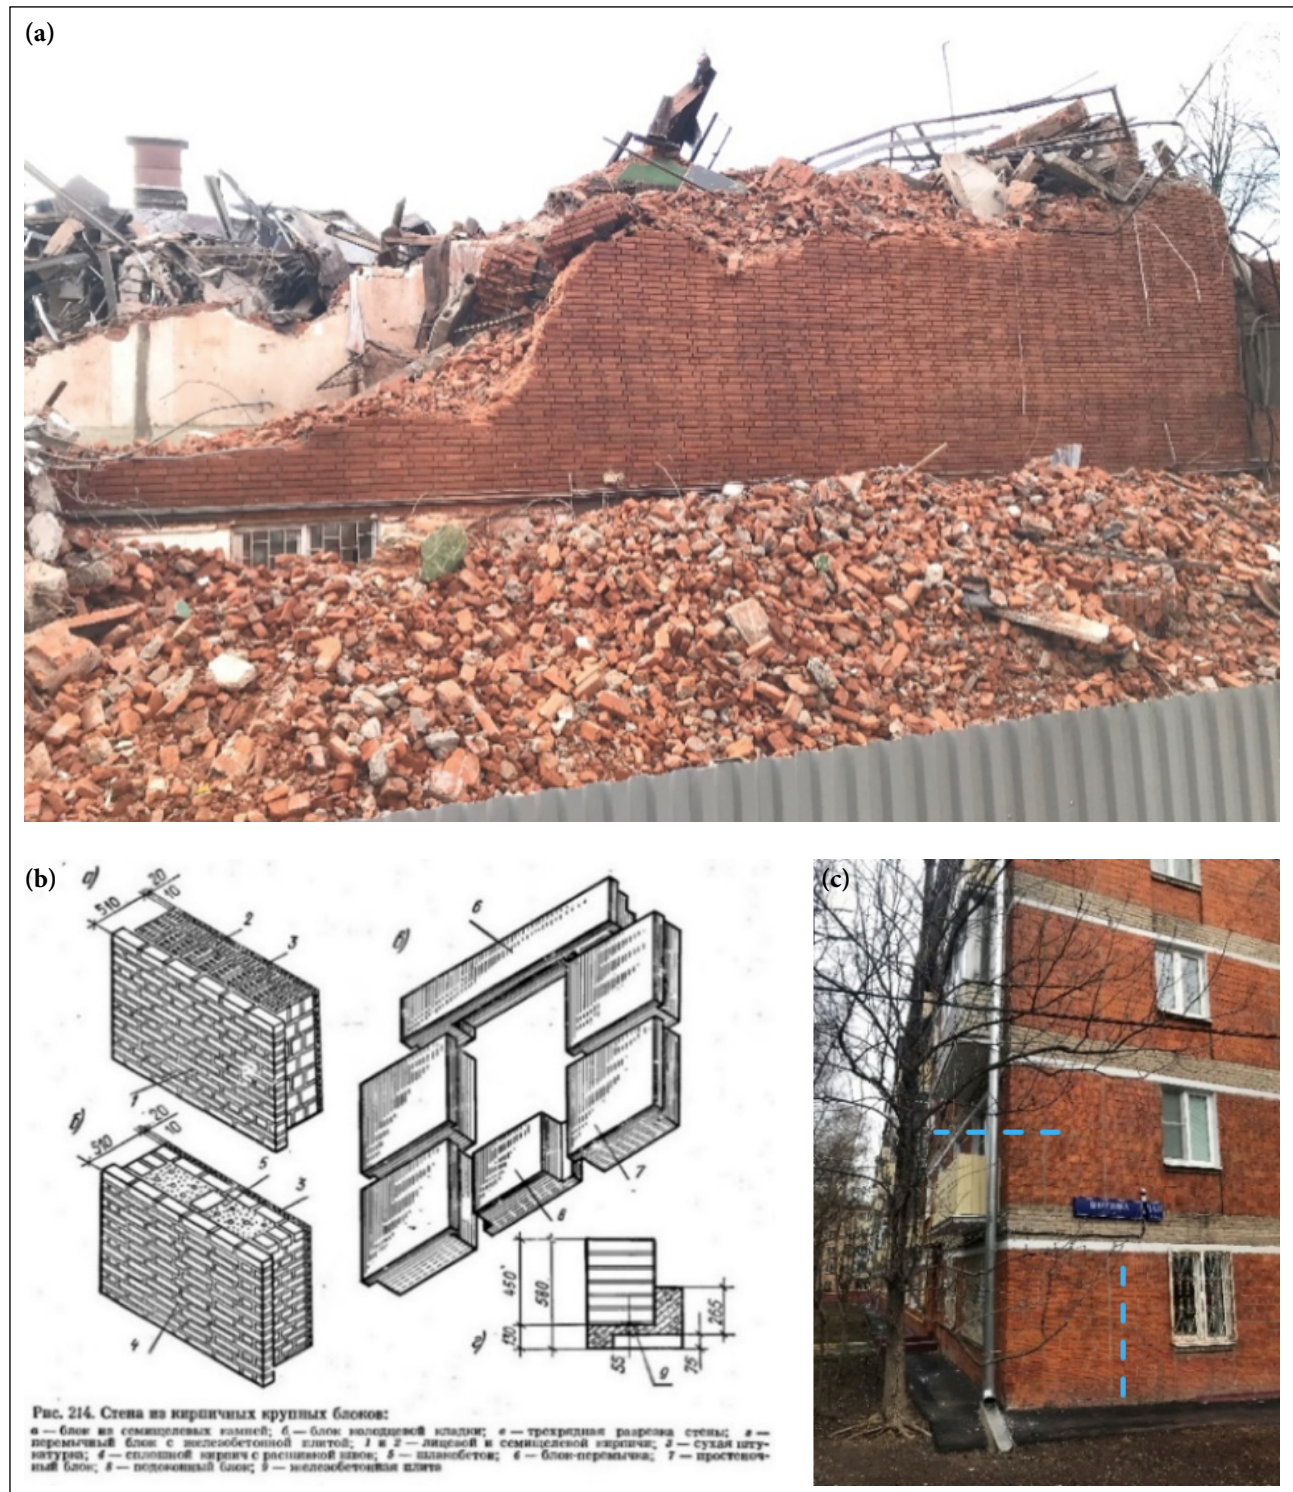
**Figure 5. (a)** The Vityaz Movie Theatre's brick walls were captured during demolition. **(b)** Schematic drawing illustrating construction with pre-built large masonry-block wall panels [38]. **(c)** The five-story mass housing project was constructed with prefabricated large-block brick wall panels in the 1960s–70s Moscow.

The craftsmanship of the walls was particularly notable, with each brick bonded using traditional techniques, a contrast to the industrial methods that dominated the era. In the 1970s, large-scale industrial construction methods—such as prefabricated large-block brick wall panels (Stena

Despite using similar materials and bonding patterns, traditionally bonded bricks and industrially produced brick panels were visually distinguishable by the horizontal and vertical joints on the façades (Fig. 5b, c). This distinction emphasized the building's departure from mass production and showcased the neat craftsmanship embedded in its walling.

The demolition process uncovered well-crafted brick units that comprised the entire thickness of the wall, mea-

suring a substantial 55 cm. This resulted in many solid bricks, which were valuable for salvage. Despite the intensity of the demolition, many of the bricks remained intact, highlighting their strong mechanical properties (Fig. 5a). With proper handling, these bricks offered an opportunity to contribute to sustainability by preserving their original properties for reuse in new construction. Even simply collecting the intact bricks after demolition would have been a significant alternative to landfilling.

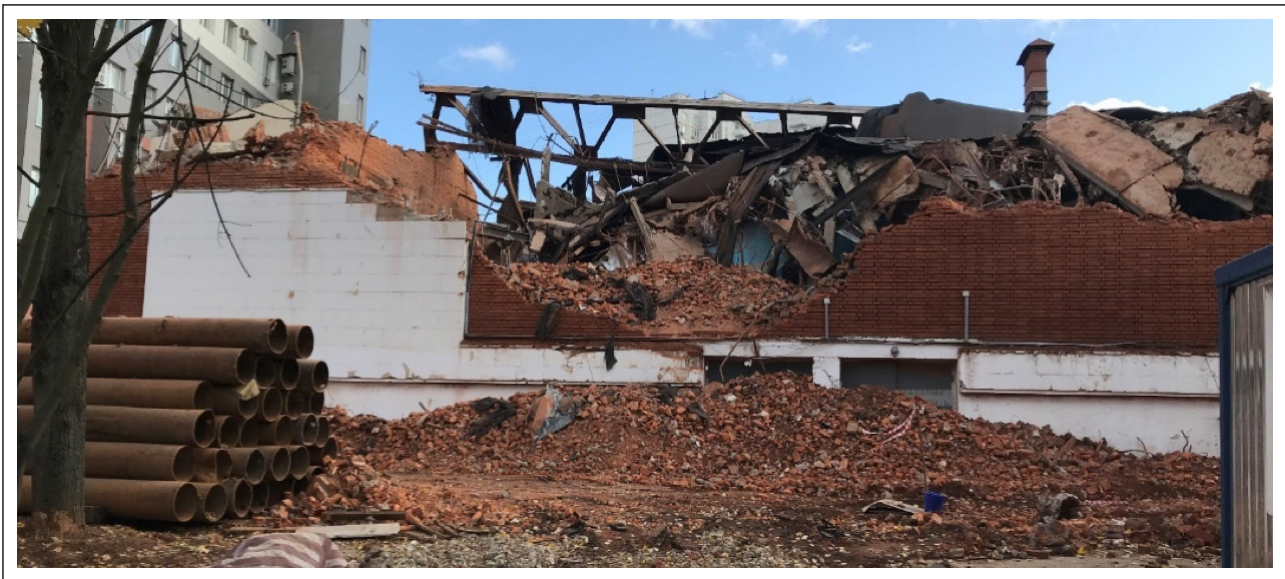
**Figure 7.** Steel roof trusses of the Vityaz Movie Theatre, captured during demolition.

The demolition process uncovered six slender steel beams, each 45 meters long and 2 meters deep, used to span the roof of the Vityaz Movie Theatre's single auditorium. This extensive use of metal was notable, given the metal scarcity that affected many industries when the building was constructed.

The exposed steel trusses that formed the auditorium's roof created a skeletal transparency, contributing to the light and airy atmosphere of the Vityaz Movie Theatre (Fig. 7). These beams were prefabricated by welding together L-shaped profiles of various sizes. During the demolition process, the quality of the metal and the joints appeared satisfactory, with partial sections remaining intact even after impacts from the machinery. As a result, these trusses seemed well-suited for resizing into shorter components for less strength-demanding functions.
