# Scientific Characterization of Historic Mortars Dating From the 15th-Century of a Historical Building in Algeria: A Case Study

This research investigates the historic mortars (Aggregate/Binder (A/B) ratio) of a historical patrimony building, dating from the 15th century, in Algeria, for restoration purposes. It is well known that thorough characterization is essential for successful restoration. To this end, several techniques, including Scanning Electron Microscopy (SEM), X-ray Diffraction (XRD), and X-ray Fluorescence (XRF), optical microscope were used to characterize the historic mortars. A mechanical test was used to characterize the compressive strength of a historic mortar. For a comprehensive characterization, A/B ratios were estimated using both Digital Image Analyses (DIA) and chemical analyses. The results obtained provided clear information on the fractions of aggregate and binder. The A/B ratios found of the historic mortars were in line with those found in the literature in historical building. It should be noted that chemical analyses were applied to all mortars, whereas the DIA method was limited to a few mortars (not applicable to earth-based mortars). The resul

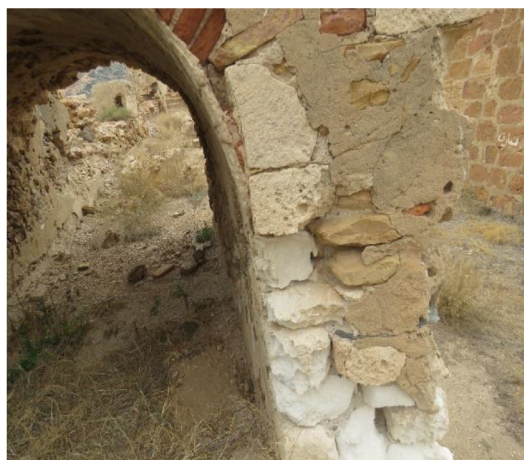
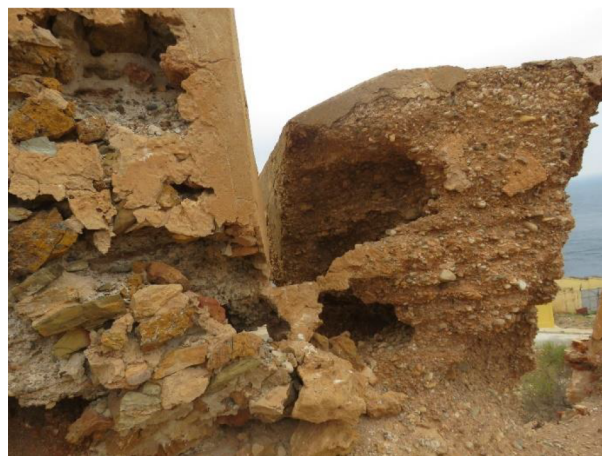
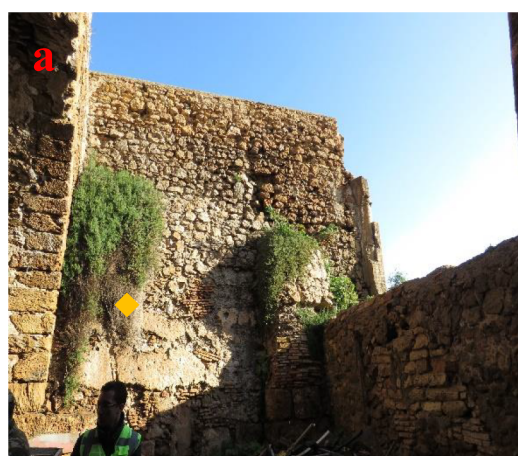
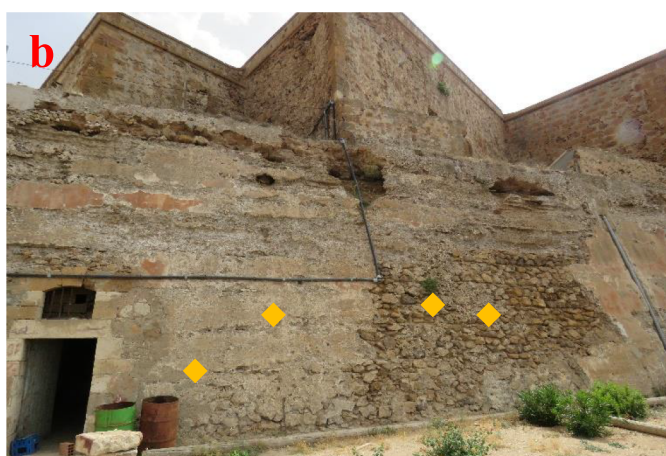
**Fig. 1.** Example of some of sampling areas (mentioned in Orange) selected to obtain and drill mortar samples: two photos above from elevation south west and North west, interior facade (a); exterior facade (facing the sea) (b).

In this investigation, to avoid abnormal parameters and for the best possible representativeness of the study's results, careful attention was paid to the selection and drilling operation of the different mortars to study. The mortars and the filling masonry materials were photographed and presented in the following table before the preparation of the thin-section, see Table 1. Each mortar used as coating or filling materials between blocks and stones were obtained from a place and has a name according to a location where it was drilled or obtained (mortars M, filling materials TV, coating E) and outside the bracket s their visual aspect in index (coarse (g), fine (f), earth (t), joint (j)). In total, sixteen samples of mortars were obtained each one from a location in the Fort. As DLNO: mortars obtained from Demi-Lune (half-Moon) place in North-West direction, DLSO: mortars obtained from Demi-Lune place in South-West direction, BSO: mortars obtained from Bastion place in South-West direction, BNO: mortars obtained from Bastion in North-West direction

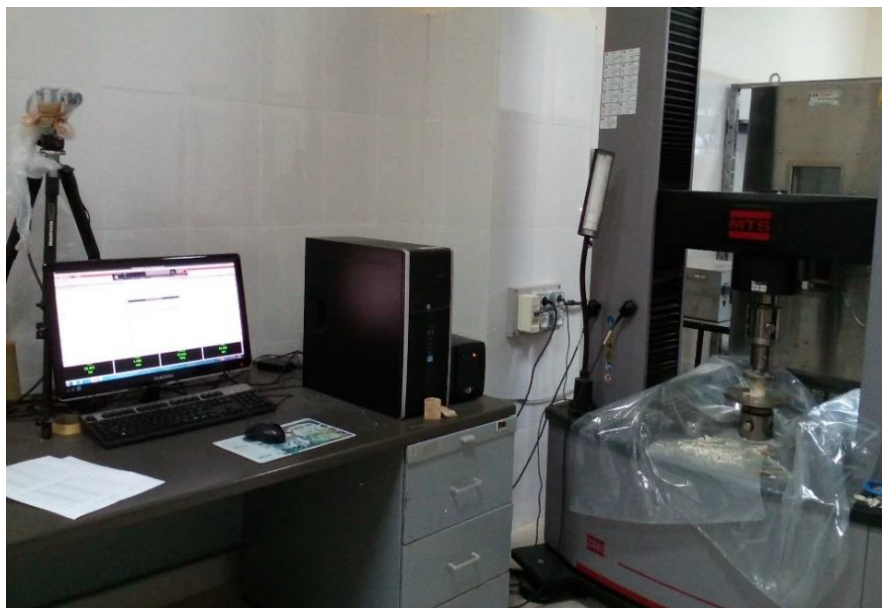
**Fig. 6.** MTS machine used for the compressive test of the historic mortar.

In order to evaluate the strength of the mortars it was possible to carry out compressive tests on one type of historic mortar. The test was carried out using a sophisticated universal machine MTS criterion C45-305E, the equipment used is a  $1/1000\ 000$  precision machine with  $300\text{kN}$  force sensor (see Fig. 6). The rate of loading used in this test was a constant load of  $0.5 \text{ MPa/s}$  on samples having a  $50 \text{ mm}$  diameter with double slenderness.
