## Evaluation of a Modern Architectural Building in terms of Sustainability: A case study of Çorlu Municipality Building

# Evaluation of the modern architectural buildings in terms of sustainability: A case of Çorlu municipality building

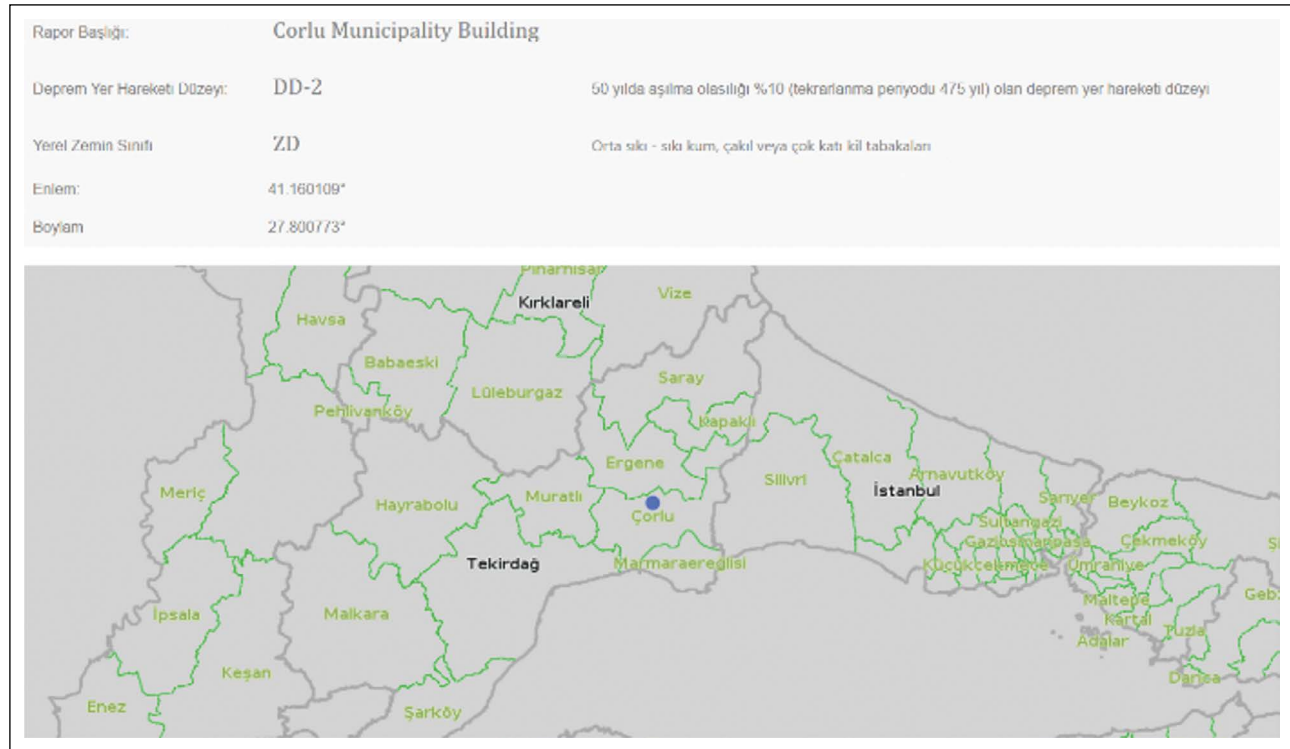
**Figure 5.** AFAD Turkey earthquake maps interactive web application - Corlu municipality building.

For the coordinates where Çorlu Municipality Building is located, the maximum ground acceleration (PGA) for ZD soil type (Tight layers of sand, gravel, or very solid clay) was determined as 0.332g from the AFAD Turkey Earthquake Hazard Maps Interactive Web Application [5]. The maximum ground speed (PGV) is 20.397 cm/sec.

Earthquake hazard maps also show that the earthquake risk prepared for the same region in those years is quite low compared to the Turkey Building Earthquake Code 2018 (Fig. 5).

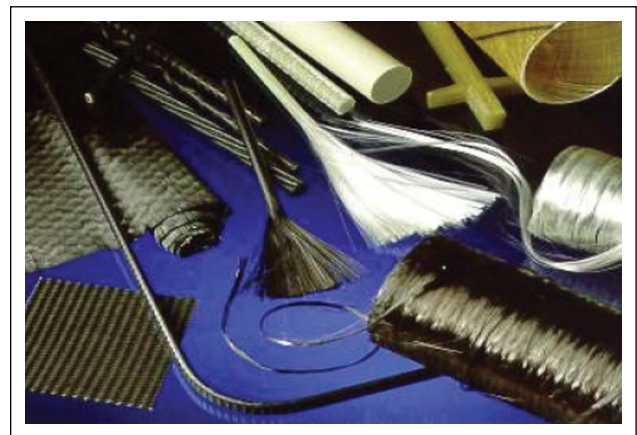
**Figure 9.** FRP composite.

Retrofitting technique with fibrous polymer, one of the new generation methods; is a system that increases the strength, ductility and rigidity capacities of the structure, obtained by bonding high-strength fibers such as carbon, glass, aramid with resins to the surfaces of building elements with different methods and shapes (Fig. 8, 9) [9].

The fibers are the load-bearing component with a high modulus of elasticity. It can be based on glass, aramid and carbon (Table 2). The fibers are attached to the reinforced concrete surface with epoxy etc. bonds with a matrix and
